Technical Data Sheet – GB34 230V HBH750 / HBH755

Trouble Shooting Guide

Repair Guide

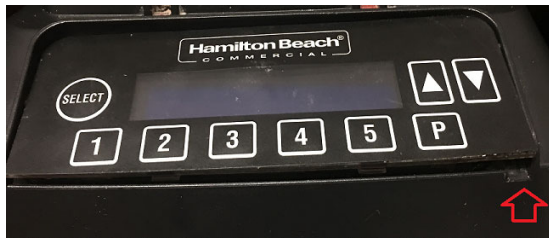
- Turn the switch to the “off” position and unplug the machine
- With a small tip screwdriver or similar tool pry the VFD assembly apart from the upper housing. There is a small location at the bottom right corner of the VFD assembly for the screwdriver to be inserted.

- Remove wire connections one at a time and install them to new VFD board
- Press the VFD board assembly back into the upper housing.

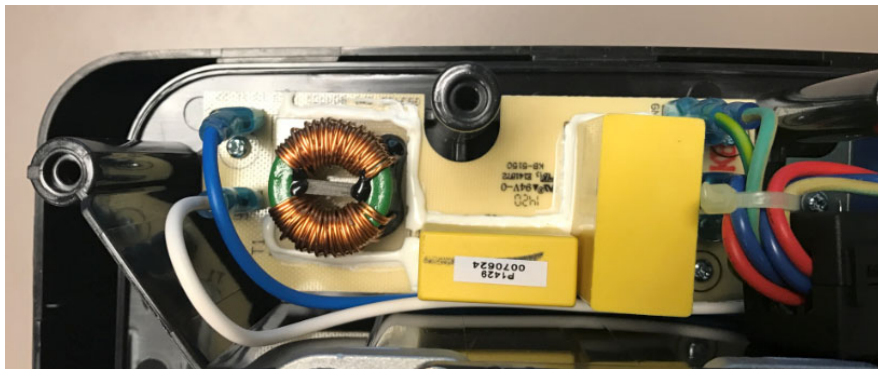
Figure 4 Interior View of RFI Board 1

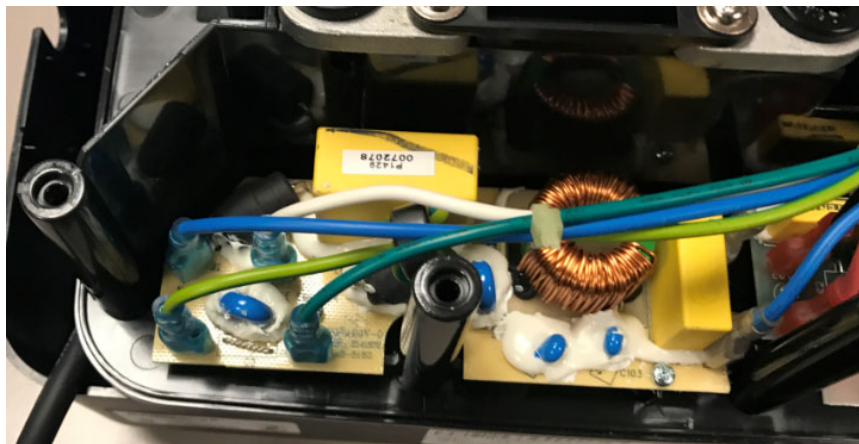
Figure 5 Interior View of RFI Board 2
